Environment Protection Authority

Groundwater Prohibition Area (GPA) – Tonsley and portions of Clovelly Park, Mitchell Park and Marion

**EPA Determination Report for consultation,
November 2020**

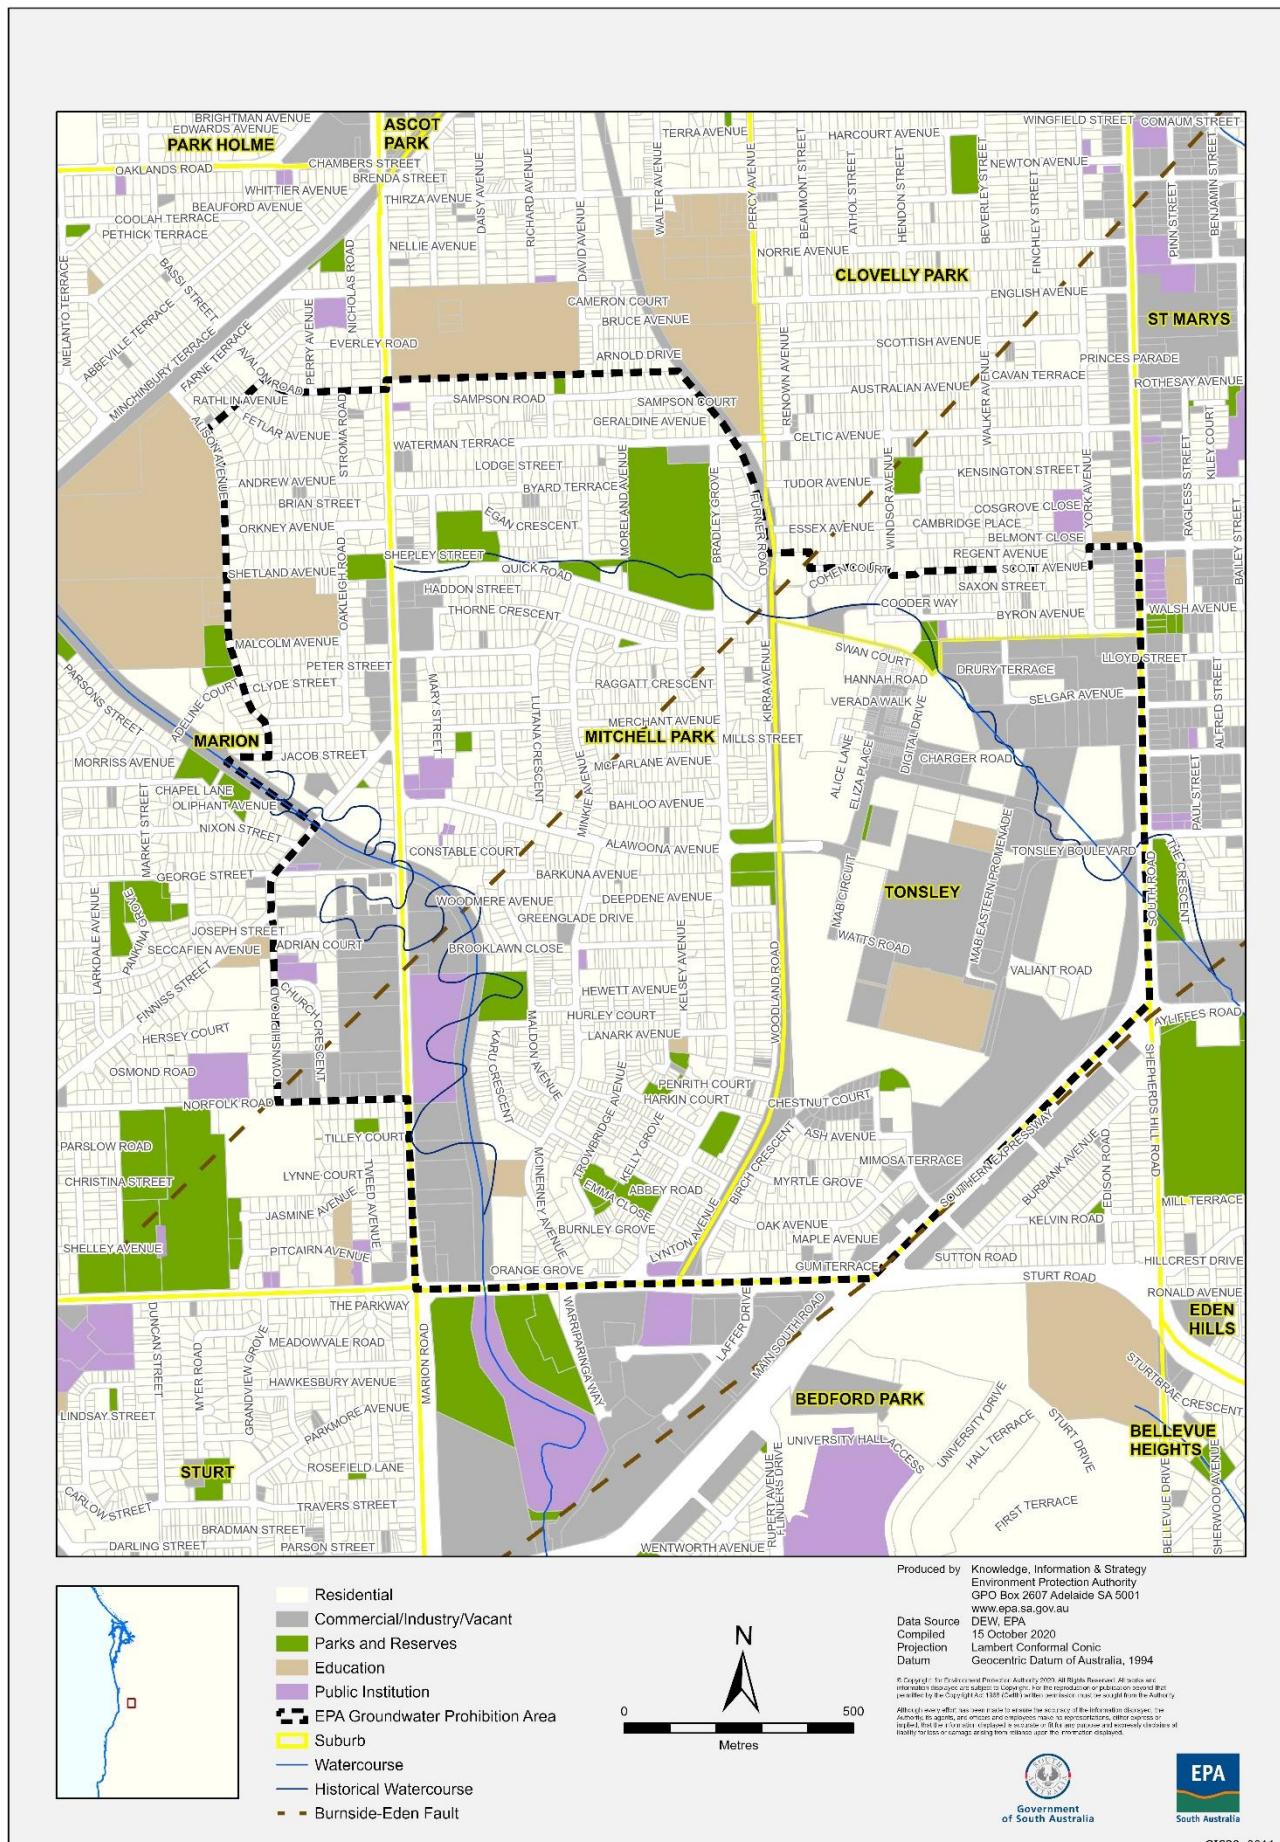
Figure 1 Map of proposed groundwater prohibition area (GPA)

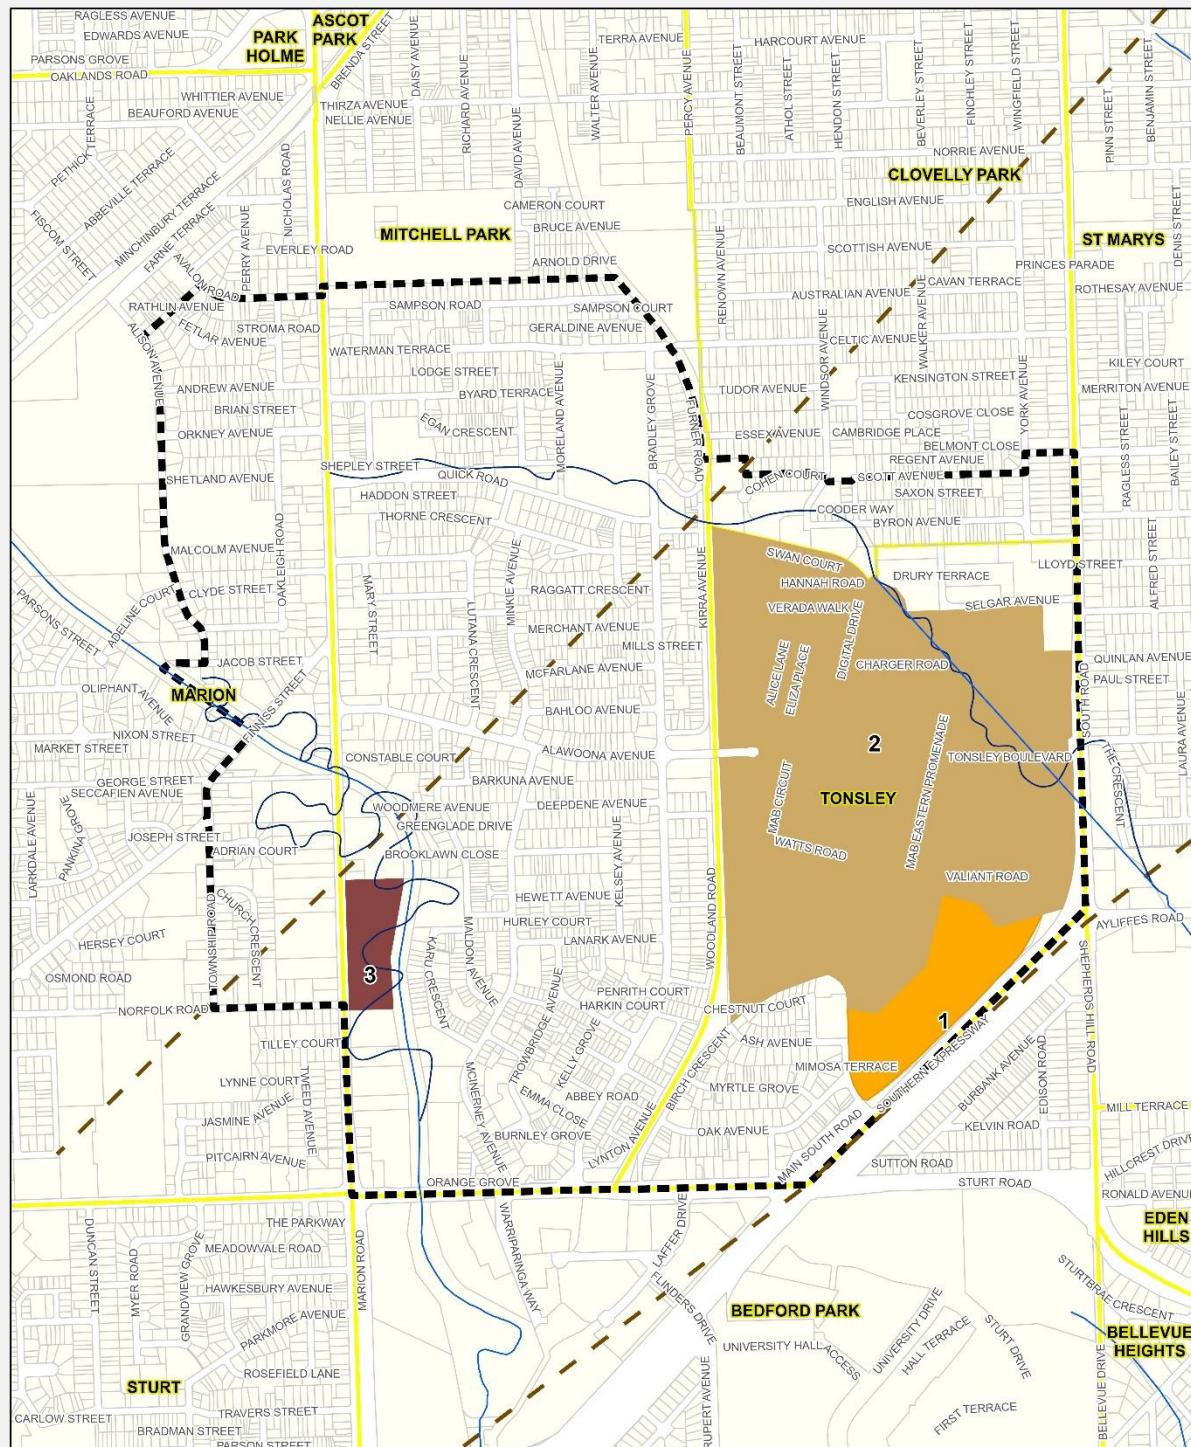
- 1 - Clovelly Park Manufacturing facility
- 2 - Former vehicle manufacturing facility
- 3 - Works depot and recycling depot
- EPA Groundwater Prohibition Area
- Suburb
- Historical Watercourse
- Watercourse
- Burnside-Eden Fault

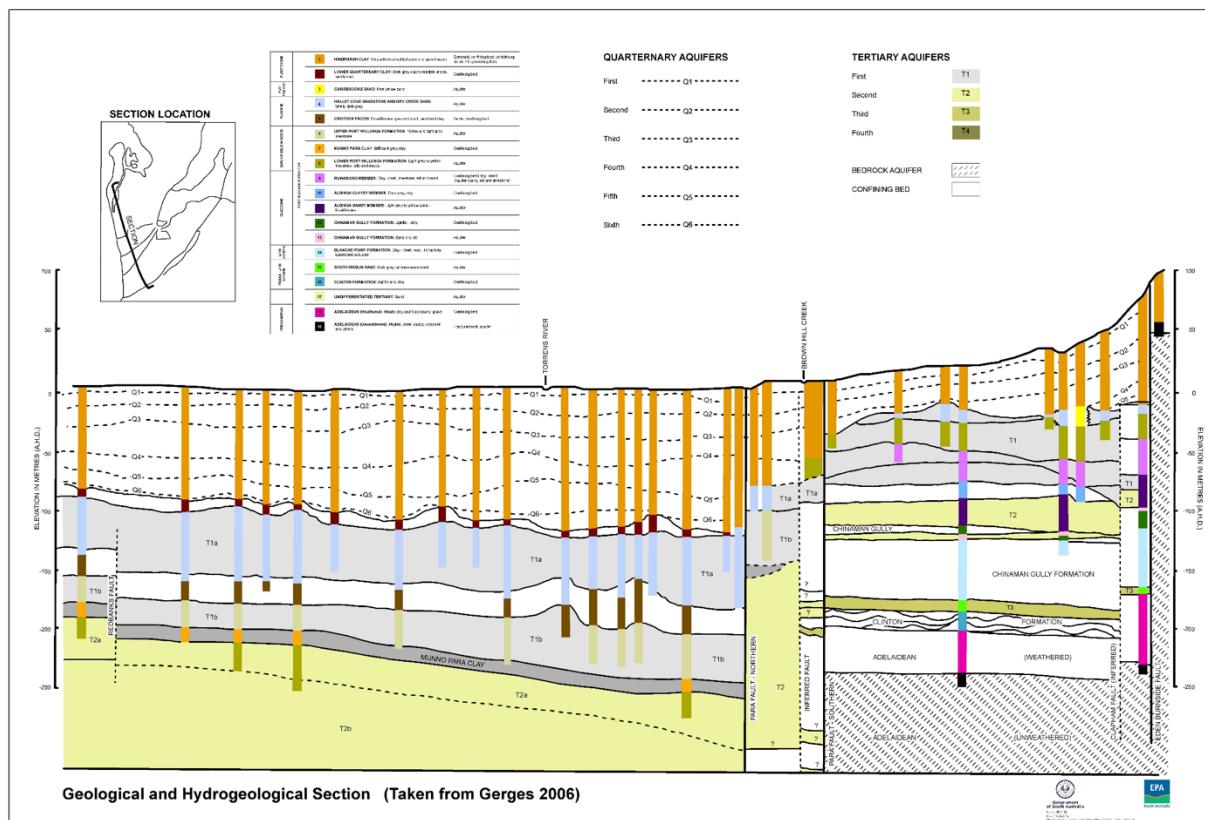
Figure 4 Geological and hydrogeological cross-section³⁸

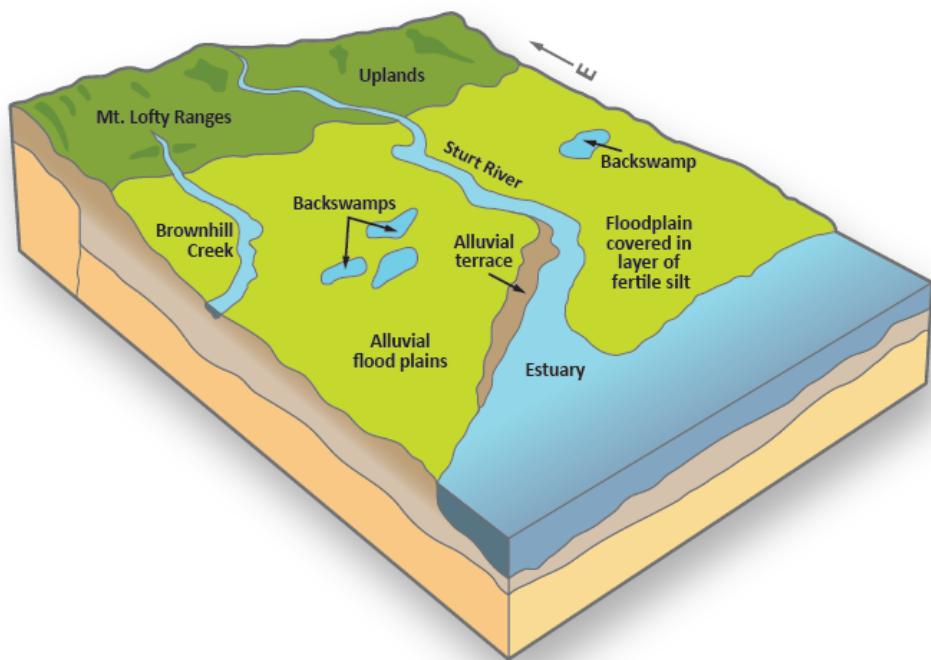
Figure 5 Conceptualised model of the Sturt River prior to European settlement

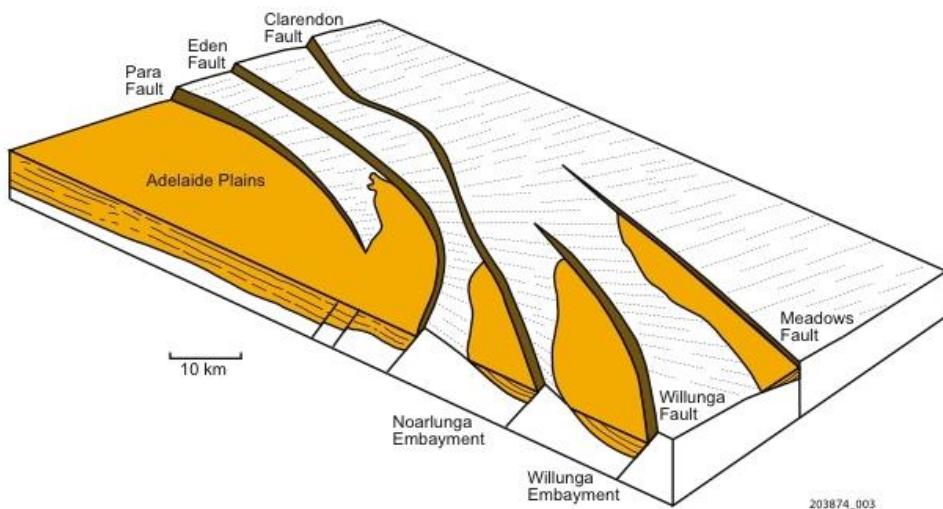
Figure 6 Interpretive cross-sectional plan of the major faults in the Adelaide region⁴⁰

Extensive structural mapping of the Adelaide Plains, undertaken in the 1960s, further defined a major fault system within the Adelaide region associated with the Mount Lofty and Flinders Ranges Delamerian Orogeny^{33 34}. Of these the Eden–Burnside Fault, observed to trend from the Little Para Reservoir in the north to Seacliff in the south, centrally passes through the Clovelly Park area ([Figure 2](#)). Historical movement within this fault zone has resulted in southerly to southeasterly tilting along the uplifted Eden–Burnside block and while generally concealed by overlying sediments, the Eden–Burnside fault marks the Adelaide Hills Face Zone ([Figure 6](#))³⁵. Due to the multiple associated fracturing along and in the vicinity of the faulted zone, a complex interaction of groundwater movement has been observed across the fault, which structurally impedes or enhances the flow of groundwater from the east to the west³⁶.

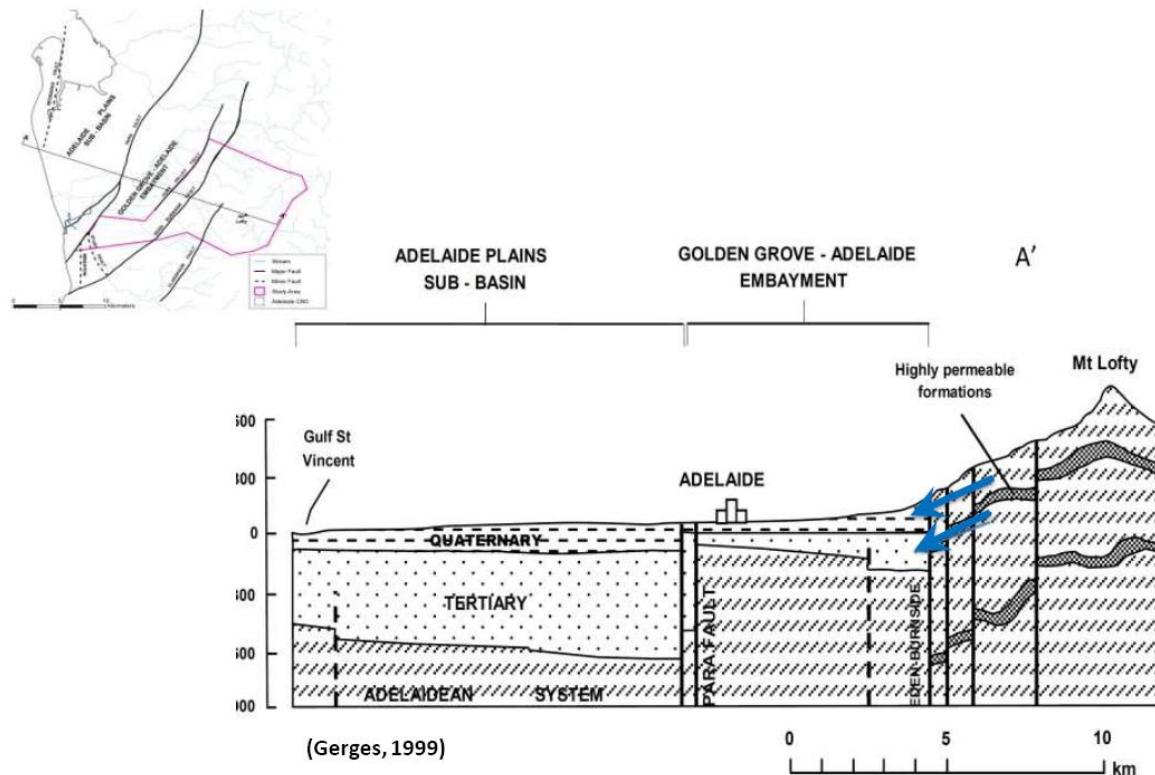
Figure 7 General flow of groundwater from the Mount Lofty Ranges across the Adelaide Plains⁴¹

Groundwater generally flows through the aquifers of the Adelaide Plains from the Mount Lofty Ranges in the east to the Gulf St Vincent in the west where groundwater discharge occurs. [Figure 7](#) shows a general cross-sectional model of the groundwater movement across the Adelaide Plains. The geology and hydrogeology of South Australia is described in more detail in [Appendix 4](#). The southeastern corner of the proposed GPA overlies the Eden–Burnside Fault and the central portion of the GPA overlies a parallel en echelon fault mapped approximately 1 km to the northwest of the main Eden–Burnside Fault ([Figure 8](#)). Groundwater chemistry analysis has inferred that groundwater may be flowing directly across the main fault line from the older fractured rock aquifer unit³⁷.

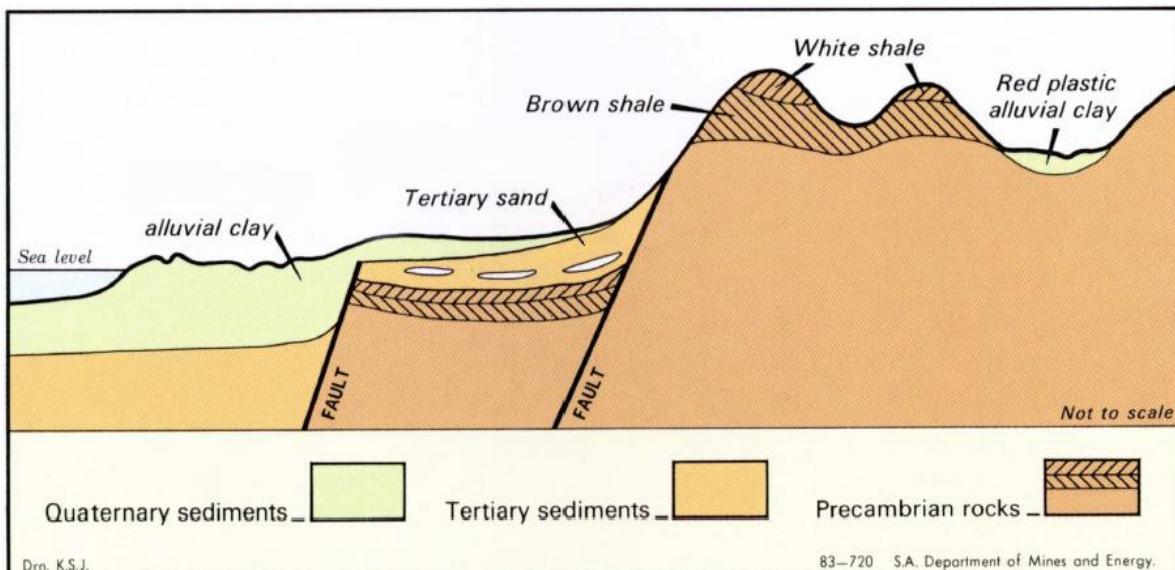
Figure 8 Interpretive cross section of major faulting in the Adelaide region⁴²

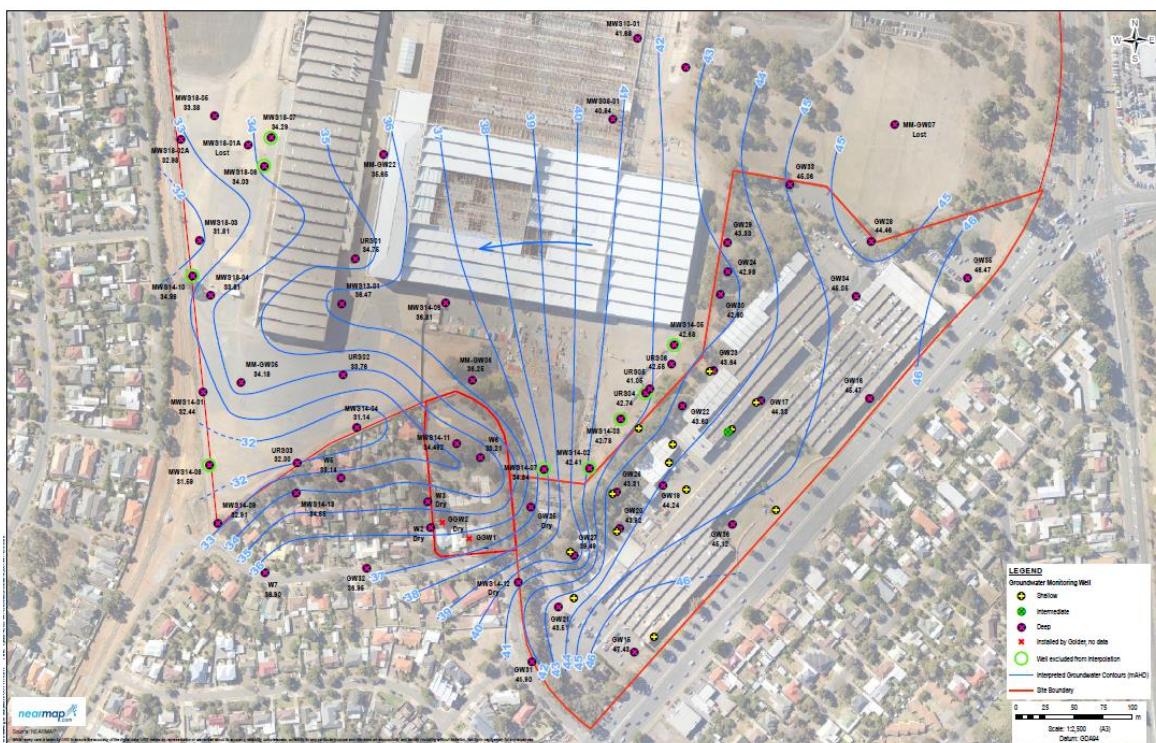
Figure 11 Monitoring well network and groundwater flow direction at the Clovelly Park manufacturing facility and southern part of the former vehicle manufacturing facility⁹⁴

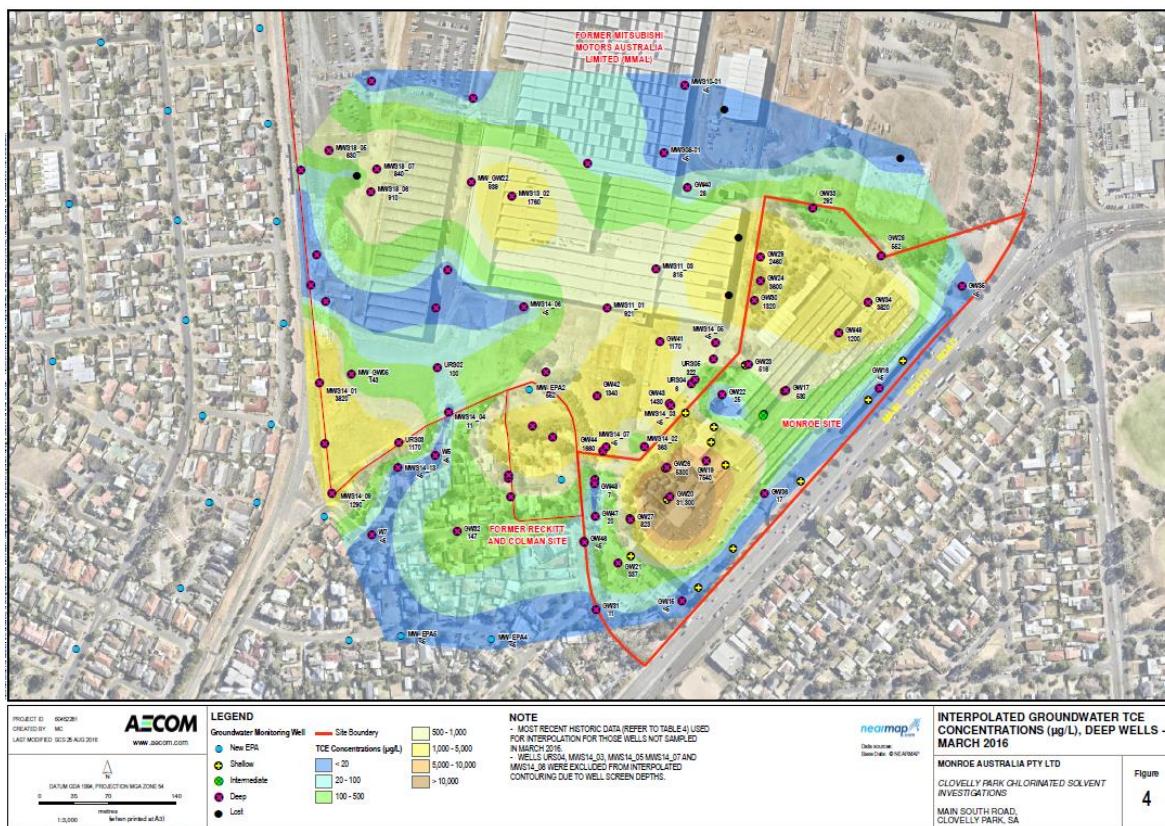
Figure 12 TCE groundwater contamination plume in August 2016 at the automotive parts manufacturing facility⁹⁵

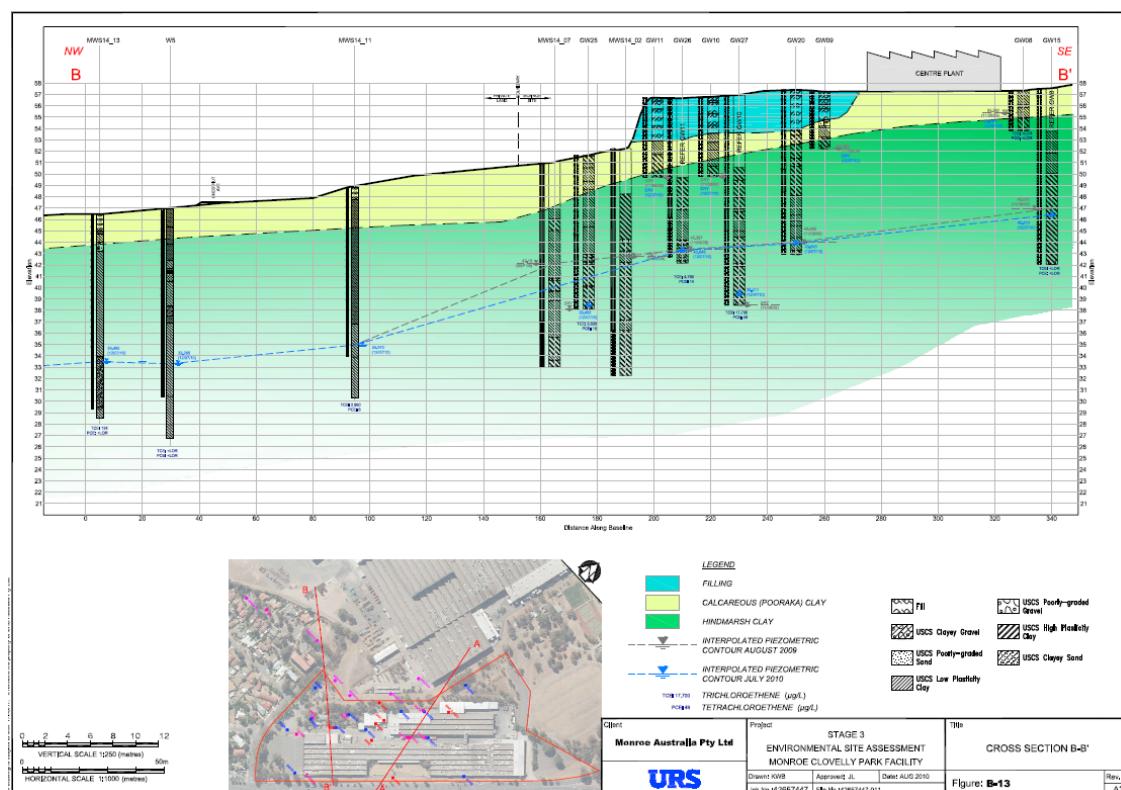
Figure 13 Northwestern cross-section of sandy aquifer within the Hindmarsh Clay⁹⁶

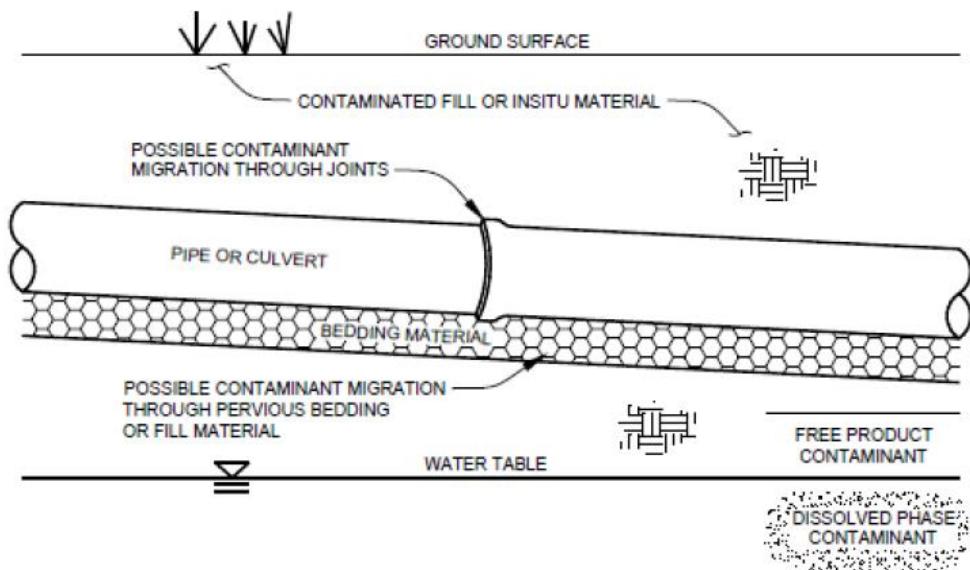
Figure 14 Example of preferential pathway movement of contaminants through an enclosed drain⁹⁷

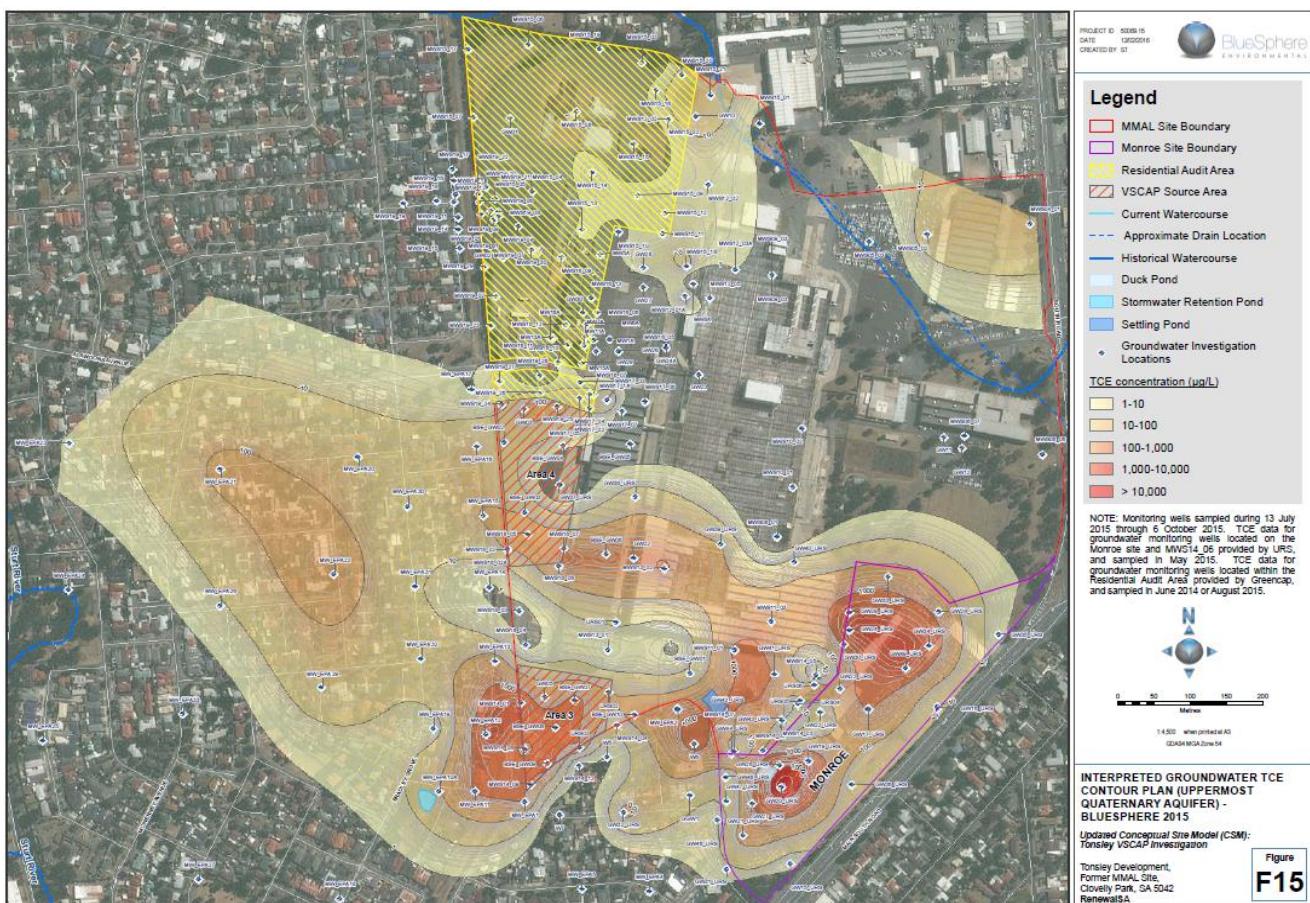
Figure 15 Interpreted groundwater TCE contour plan for Hindmarsh Clay aquifer⁹⁸

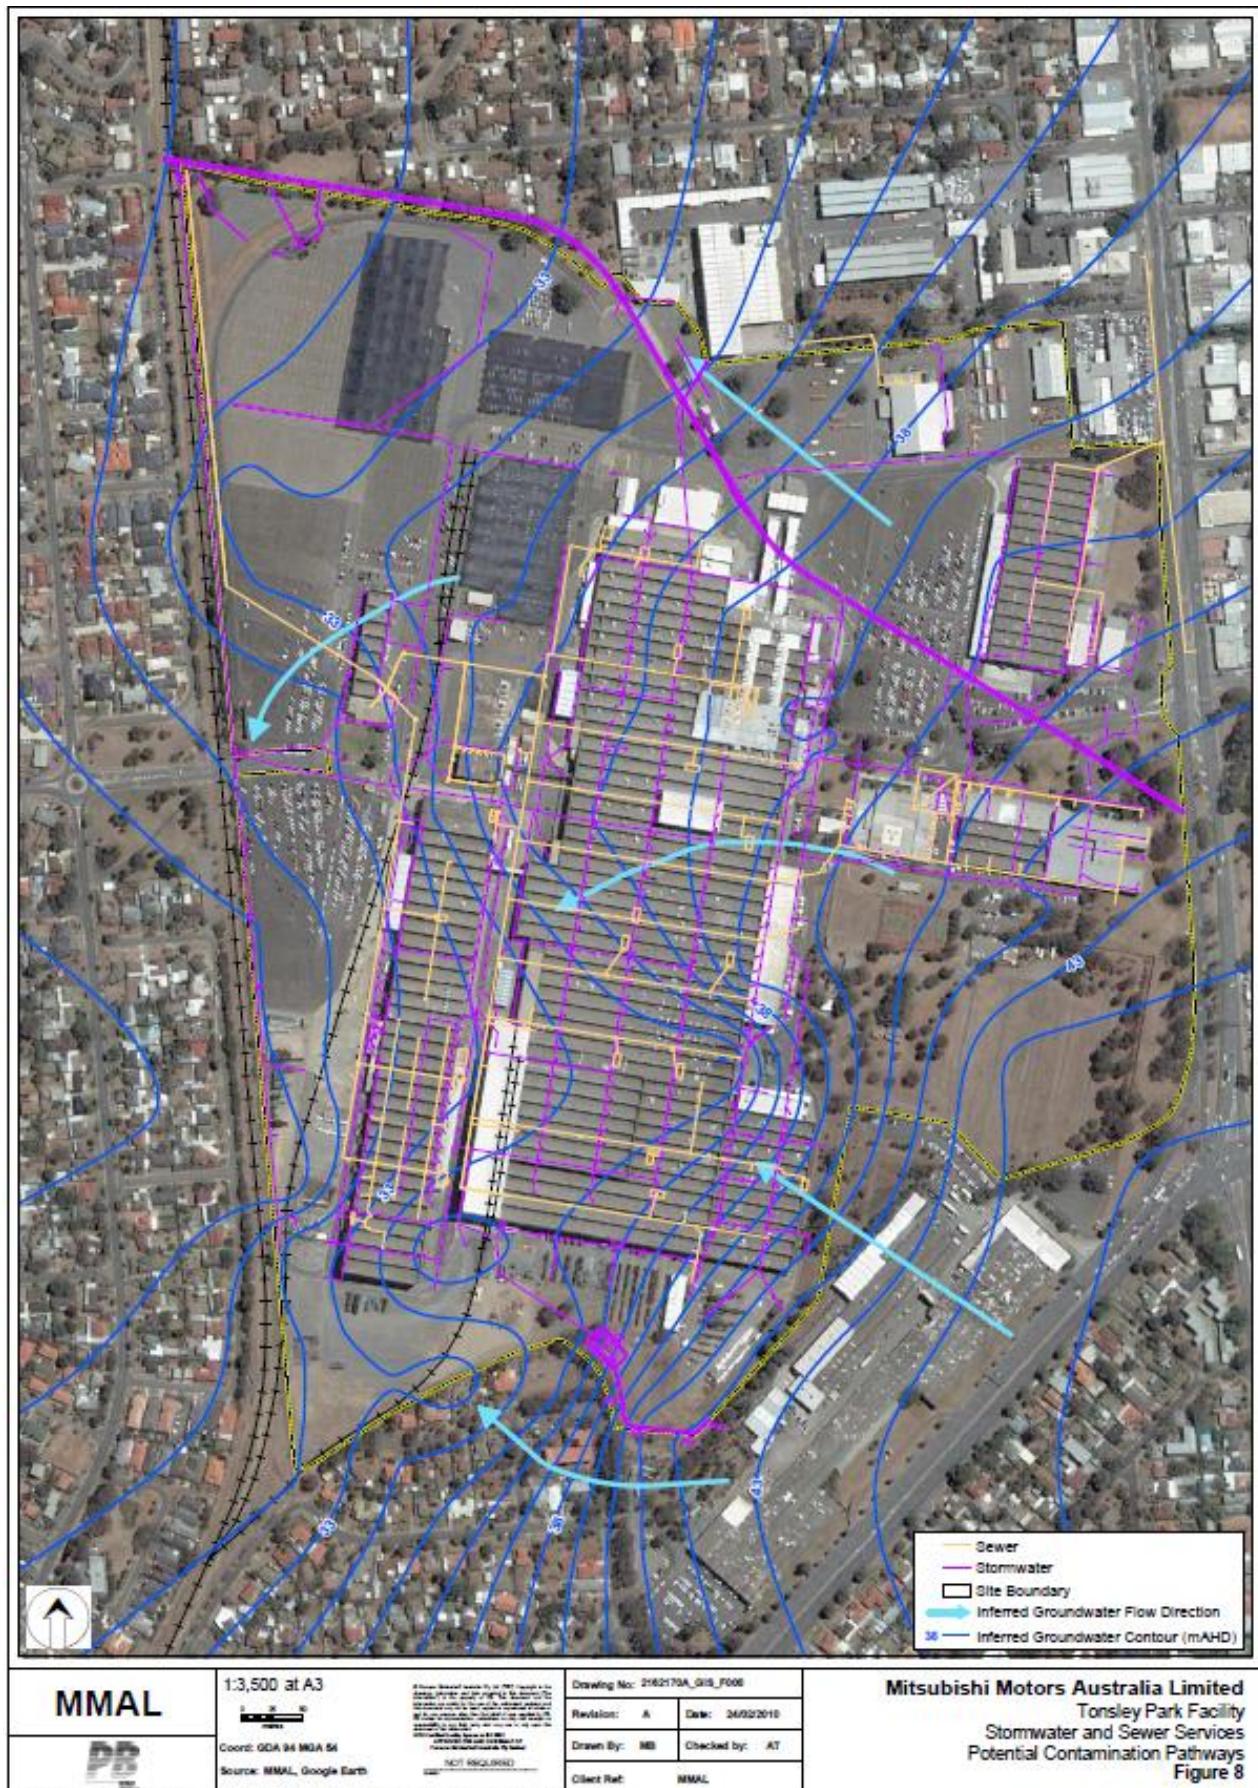
Figure 18 Interpreted groundwater flow direction, including stormwater drains¹³⁵

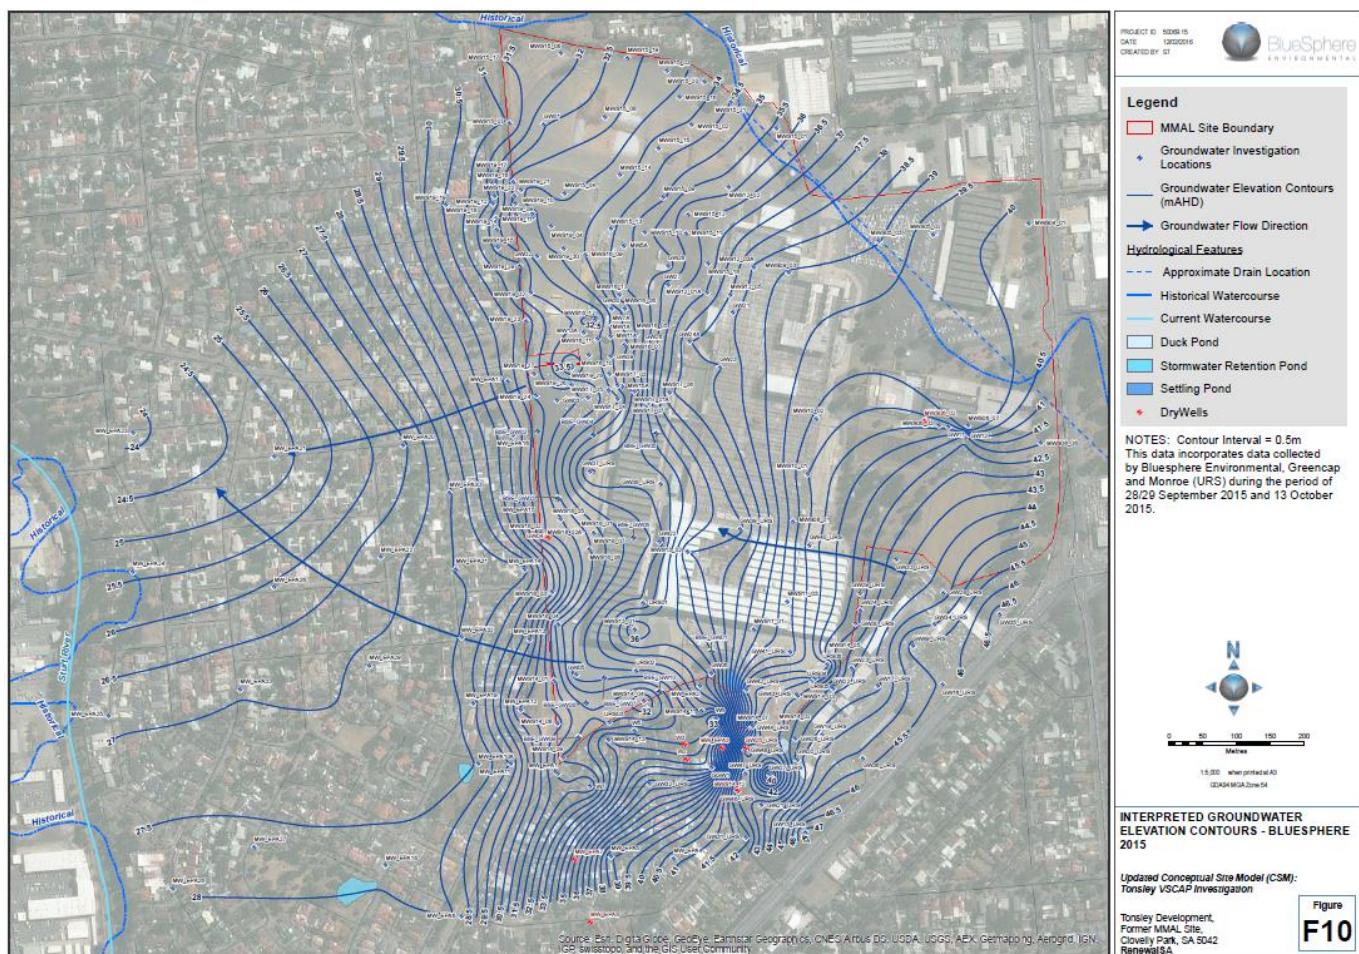
Figure 19 On and off-site interpreted groundwater flow direction¹³⁶

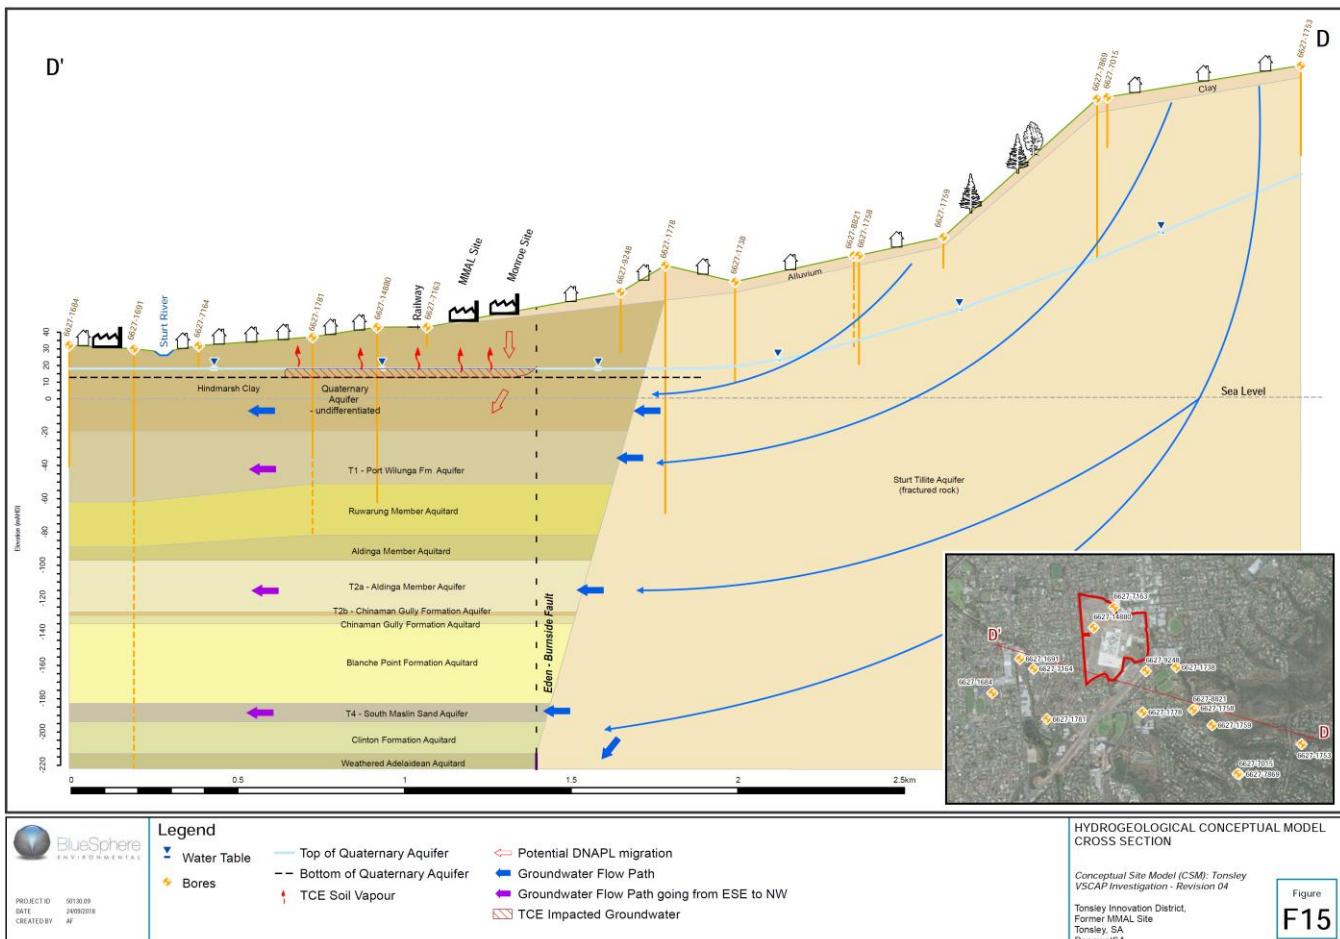
Figure 20 Interpreted regional hydrogeological cross section¹³⁷

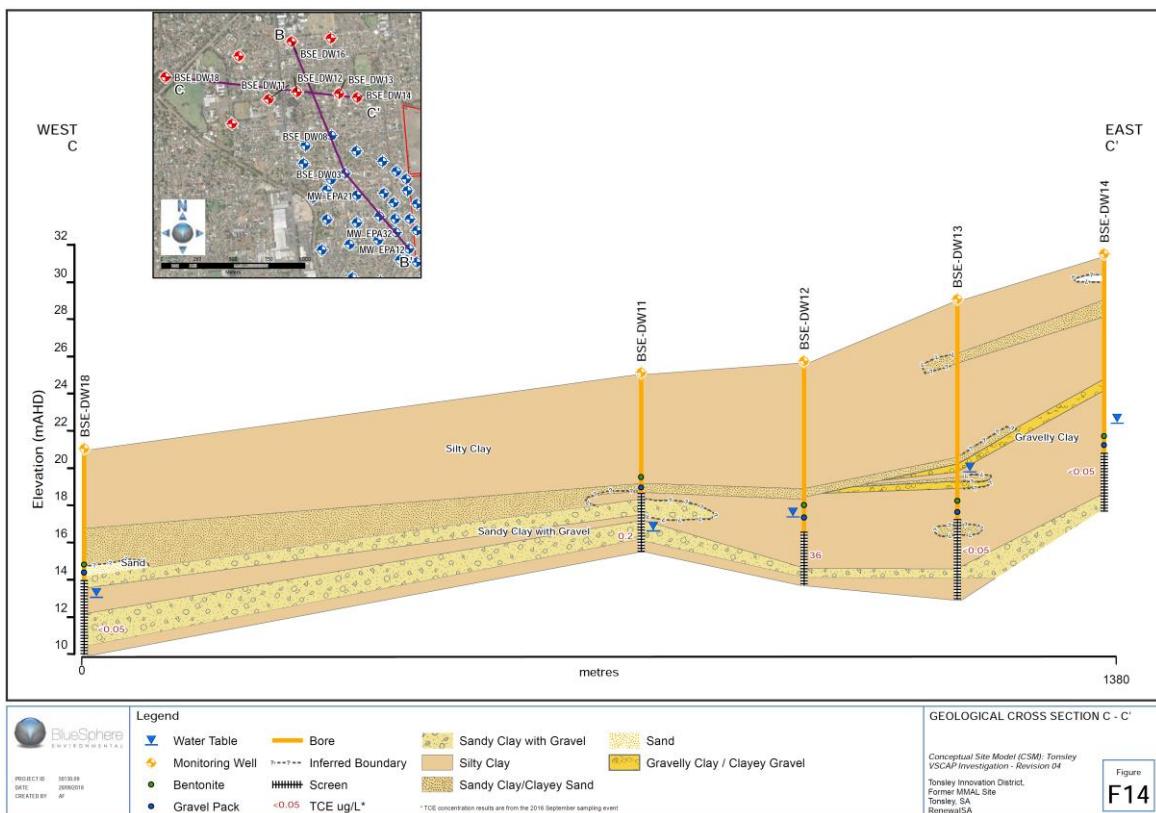
Figure 21 Tonsley/Mitchell Park cross-section¹³⁸

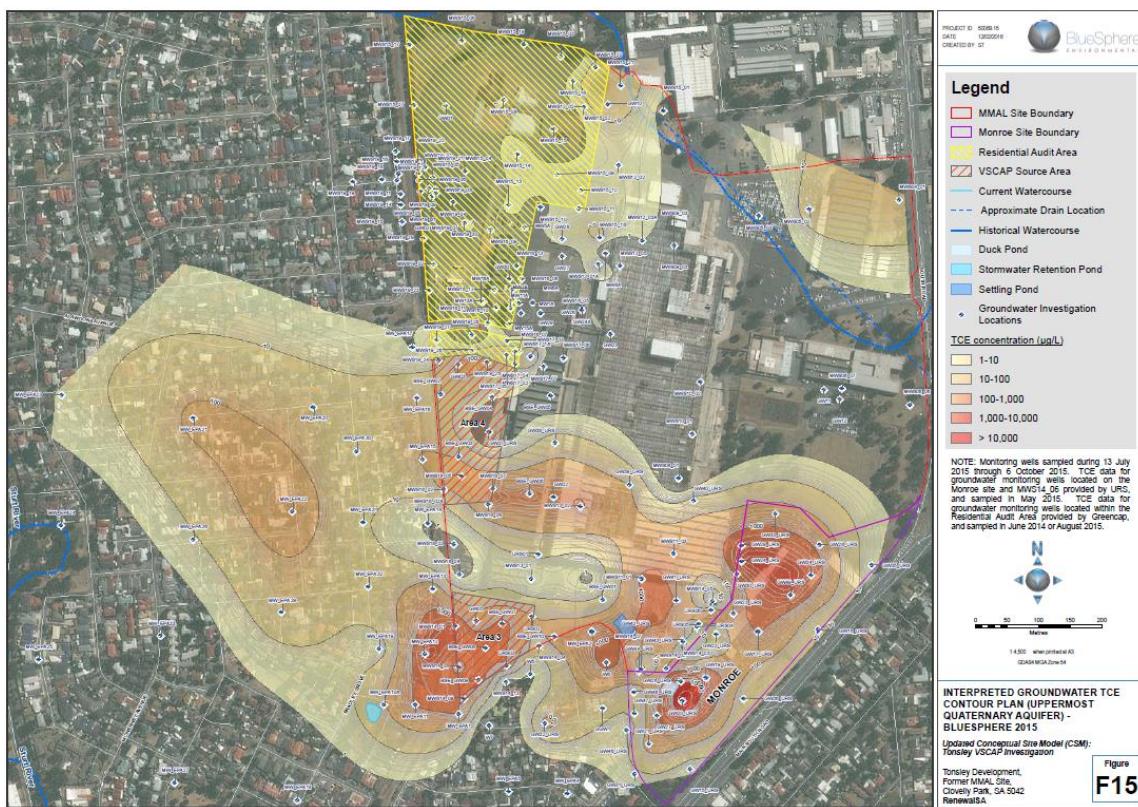
Figure 22 Interpreted groundwater TCE contour plan for Hindmarsh Clay aquifer¹³⁹

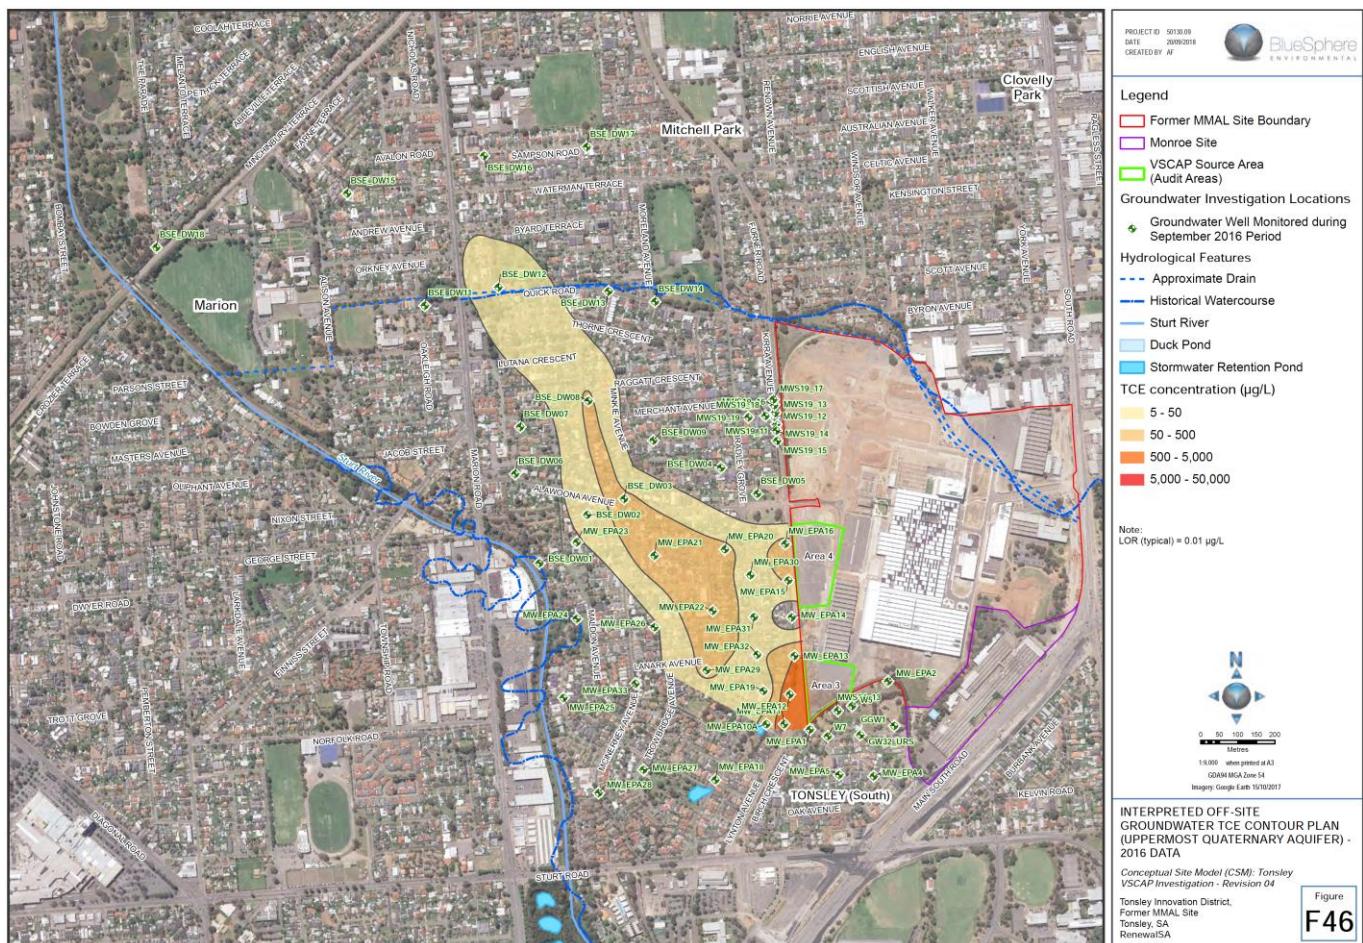
Figure 23 Interpreted TCE concentrations in groundwater within the Mitchell Park area¹⁴⁰

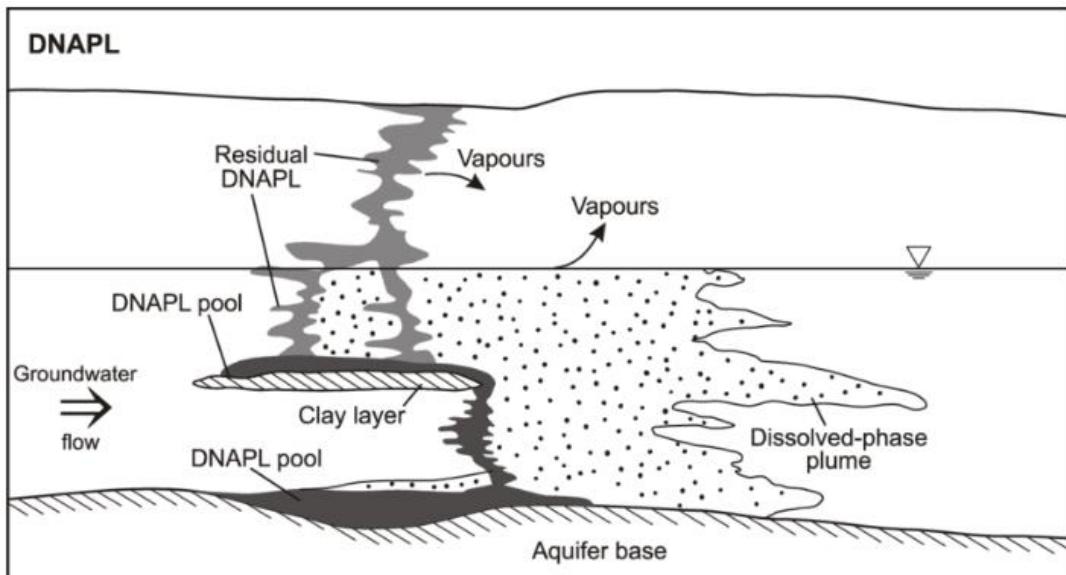
Chlorinated hydrocarbons are denser (heavier) than water. When released to the environment they can leach through the soil into groundwater and form a dense non-aqueous layer (DNAPL). Depending on the sediment type, microbial activity within the groundwater and aquifer hydraulic conditions, chlorinated hydrocarbons may persist for hundreds of years in aquifer sediments and groundwater¹⁵⁹.

Figure 25 Conceptual model of DNAPL (dense non-aqueous phase liquid) release¹⁶⁰

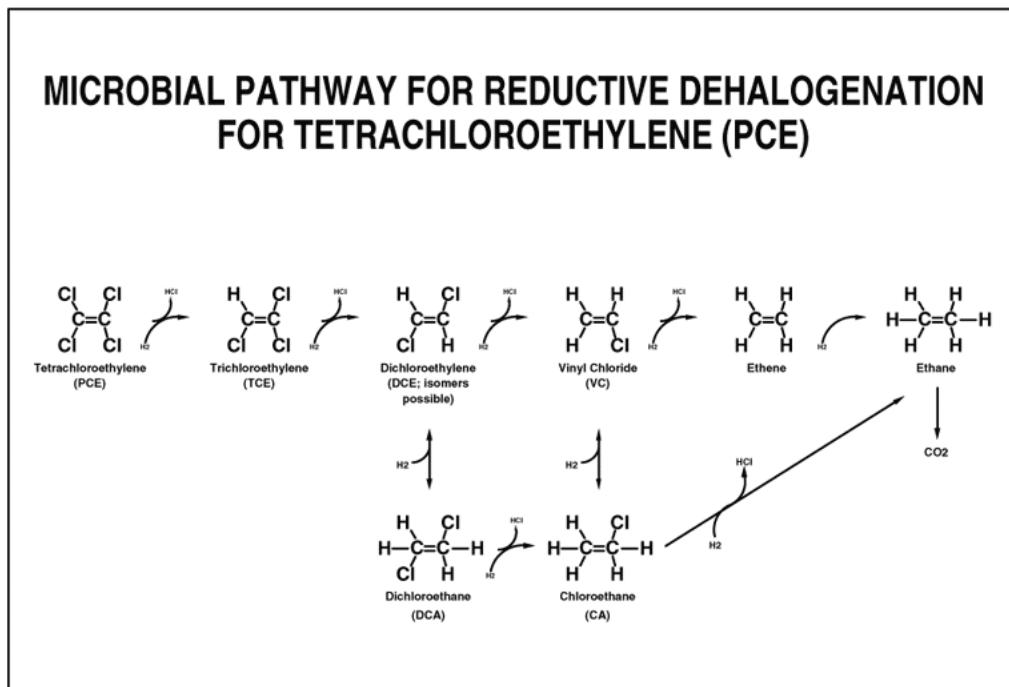
Breakdown of the chlorinated hydrocarbons via reductive dehalogenation to ethene may occur under anaerobic conditions and PCE can be intrinsically biodegraded to form additional chemicals of concern such as TCE, DCE and VC. Biodegradation via microbial activity occurs when the groundwater conditions are suitable, resulting in the capacity to remove contaminant mass and reduce the plume concentrations¹⁶¹

Figure 26 Microbial pathway for reductive dehalogenation for tetrachloroethylene (PCE)¹⁶²

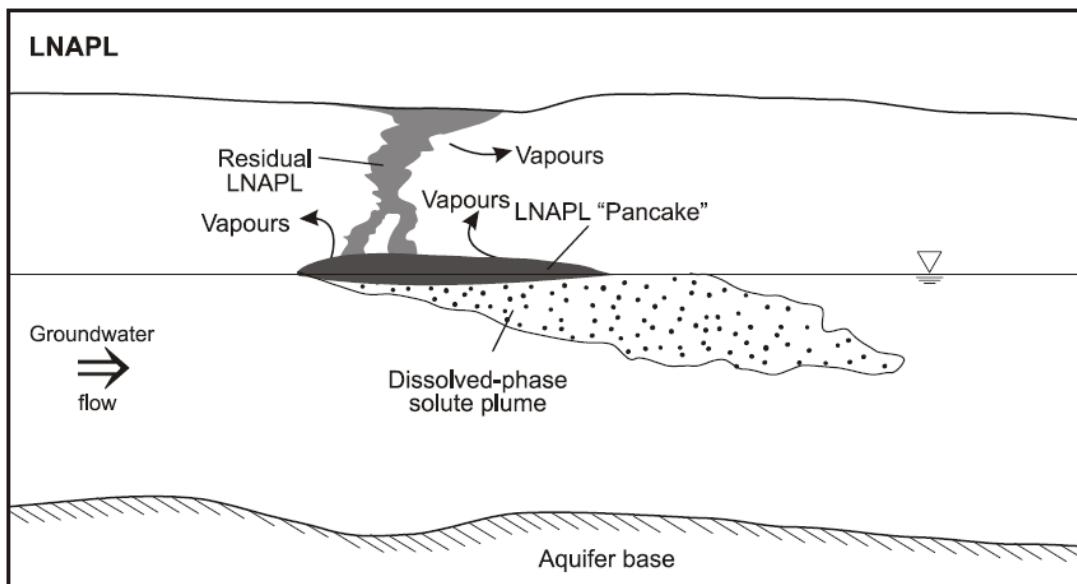
Figure 27 Conceptual model of LNAPL (light non-aqueous phase liquid) release¹⁶⁶
