AUGUST 2021 UPDATE

Ngongotahā Flood Review Project

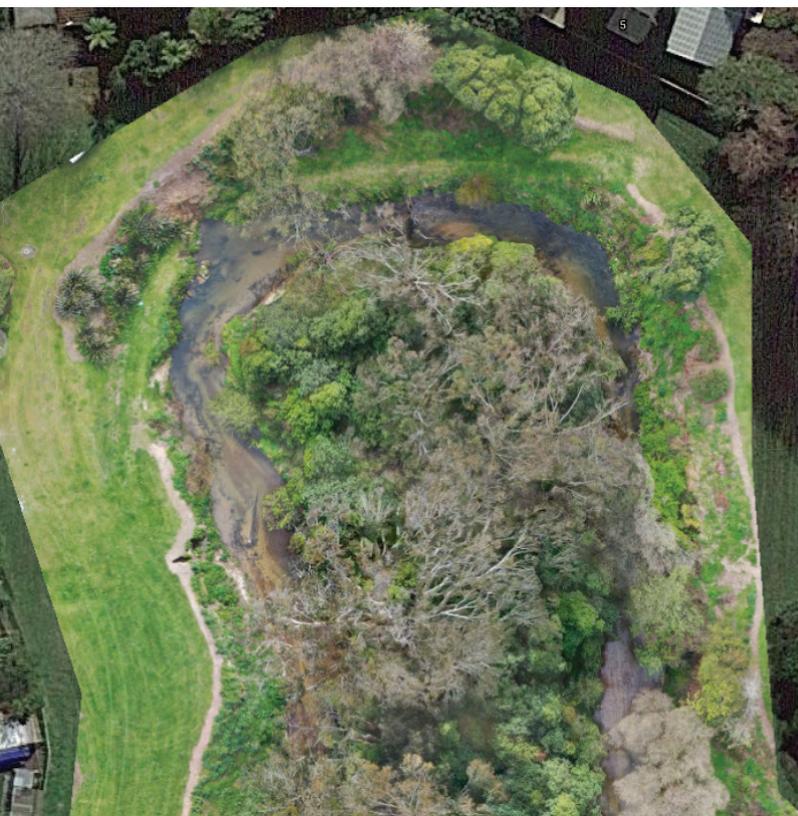
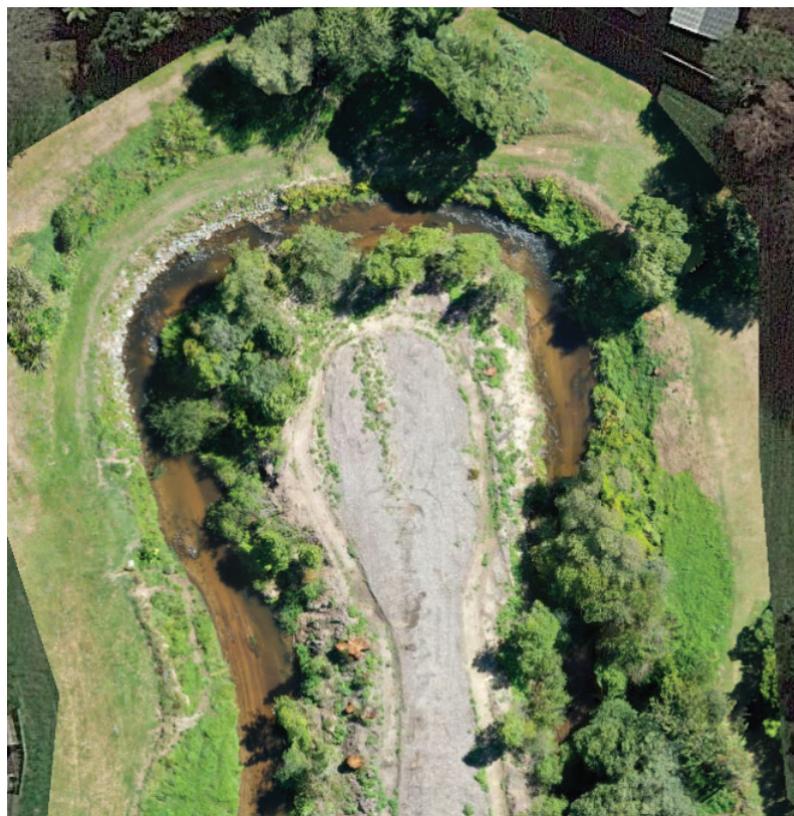
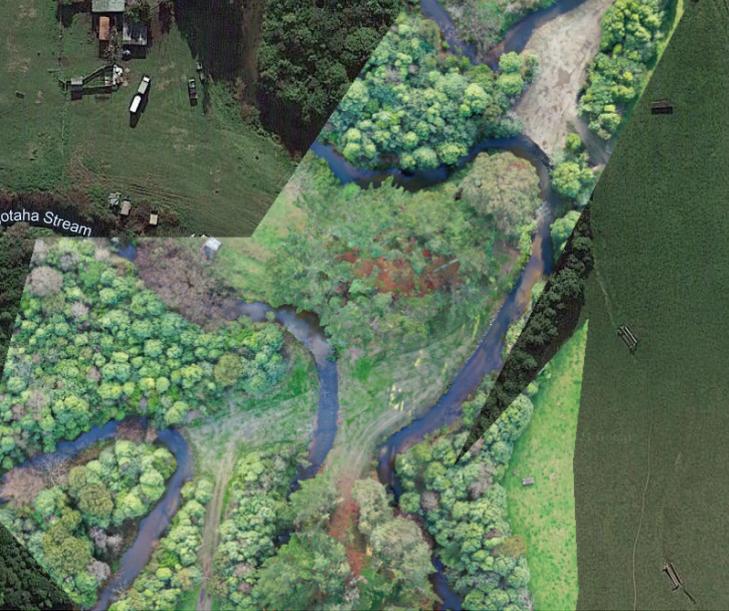
STREAM MAINTENANCE WORKS BEFORE AND AFTER

- Maintenance of various spillways along the stream including: vegetation maintenance, reshaping, rock armouring, hydroseeding for re-stabilisation and maintenance of pest plants.
- Additional 300 tonne of rock brought in to replenish existing armouring along the stream.
- Flow improvements and vegetation management adjacent to 7 Western Road.
- Final erosion site from flood event remedied with 500 tonne of rock armouring, creation of maintenance bench and hydro-seeding.
- Gum removal on Peninsular near Streamdale Place.
- Removal of several windblown trees adjacent to stream.
